## BEARING COATING TO IMPROVE FATIGUE AND LATERAL FRETING OF A LINEAL GUIDED SYSTEM, REDUCE HERTZ PREASURES AND FRICTION

HP INC

# BEARING COATING TO IMPROVE FATIGUE AND LATERAL FRETING OF A LINEAL GUIDED SYSTEM, REDUCE HERTZ PREASURES AND FRICTION

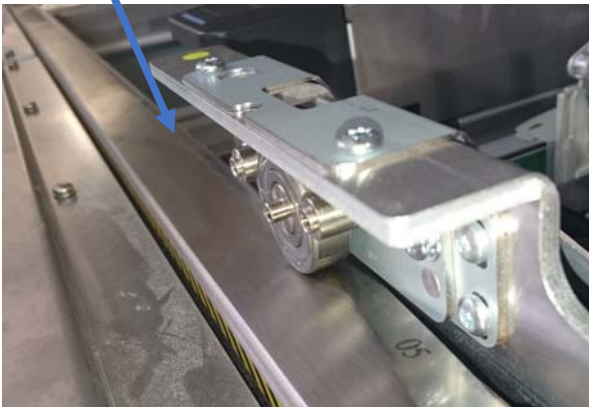
ISSUE WITH BEARING HERTZ PRESSURE IN FRONT BAR

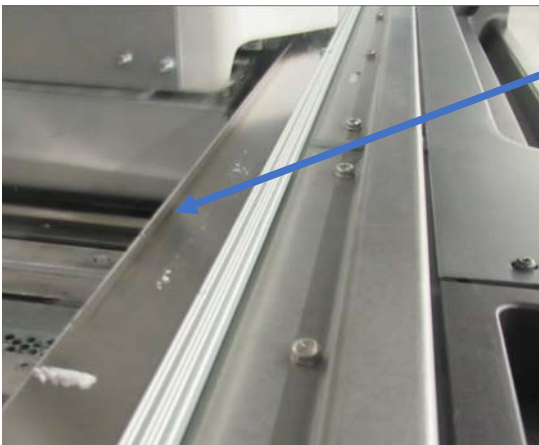
CRAIT FRETING

FRONT BAR FRETING SUPERFICIAL MARKS

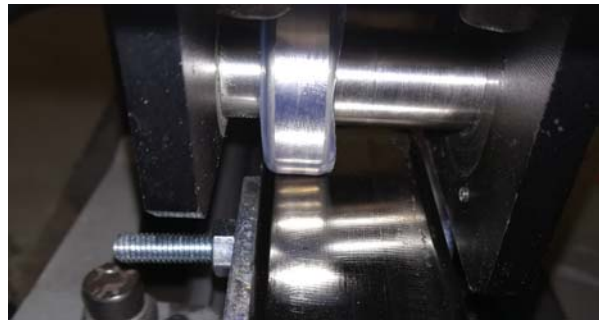
Coated Bearing after cycling 50000 times with a coating and a load of 80N → no visible effects.

This demonstrates that the hertz pressures has been reduced and fatigue and lateral freating effects have been improved.
