USER DIAGNOSTIC FOR PIP OFFSET WRONG CALIBRATION SITUATIONS

HP INC

User Diagnostic for PIP Offset wrong calibration situations

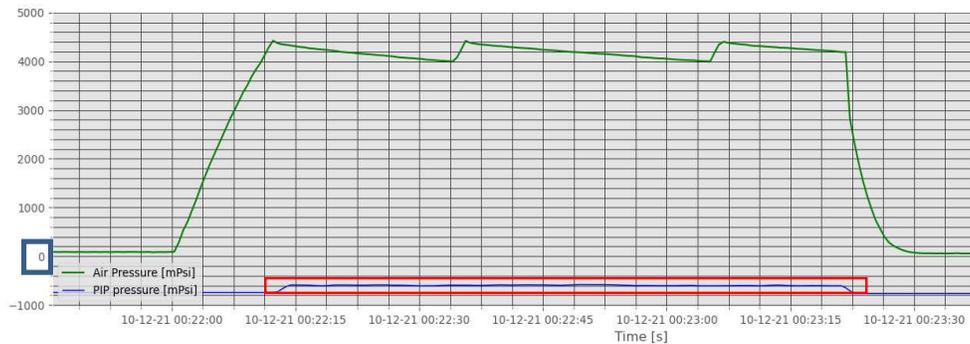
Figure 1 corresponds to a case of a PIP affected by a *PIP Offset wrong calibration*. It can be seen that the PIP pressure is around -600mPsi when the APS is pressurized, while the expected value should be around 0mPsi since the PIP is directly connected to the Dugong, thus the ink channel and the air channel are at the same pressure.

Figure 1. PIP affected by a PIP Offset wrong calibration

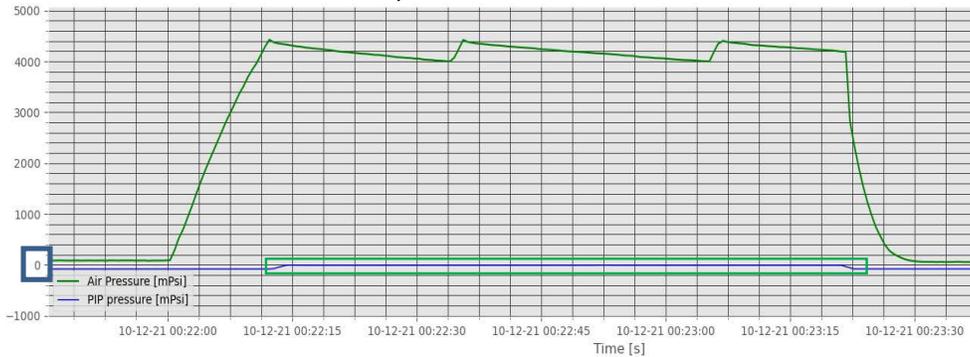
Figure 2 corresponds to a PIP Offset properly calibrated. It can be seen that the PIP pressure read is around 0mPsi when the APS is pressurized.

Figure 2. PIP offset properly calibrated
